## MICROSTRUCTURAL DEGRADATION OF BOILER HEADERS STEELS UNDER LONG TERM EXPOSURE TO HIGH TEMPERATURE

*This paper describes the process of degradation of the structure of the inlet header of the intermediate reheater (MPr) 2 input header at the boiler of Unit 7 of the Thermal Power Plant Kakanj, determined on the basis of tests of replicas and hardness at characteristic places of the header. Headers, with minor delays, have been in continuous operation since 1988. Hardness was tested at replica pickup sites, on the basis of which the correlation between structure degradation and hardness drop resulting from exploitation during the long-term high-temperature operation was estimated.*

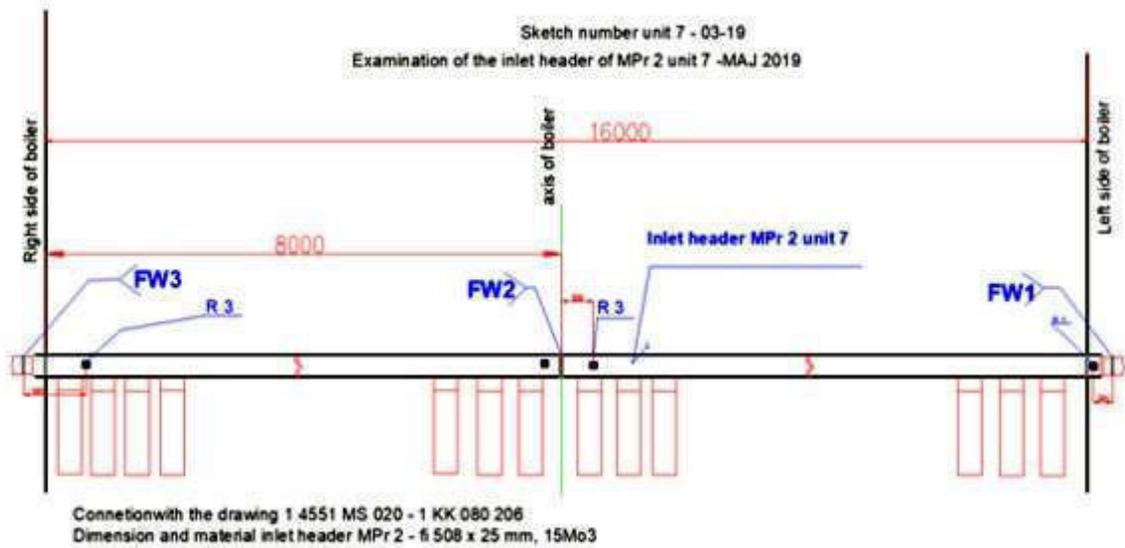
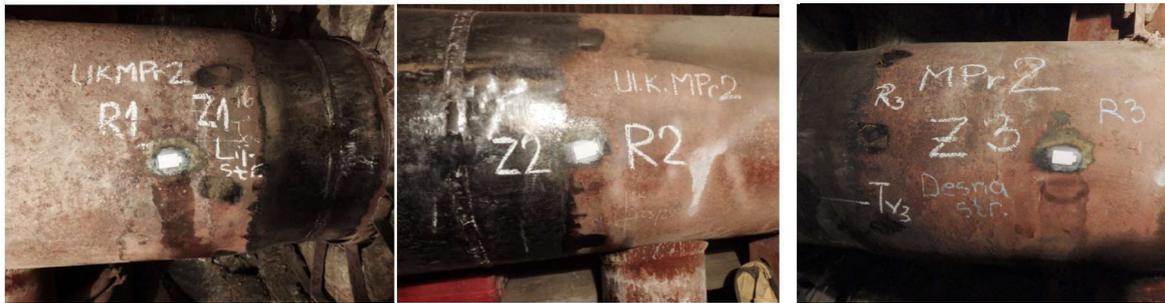
Figure 4. The position of the replicas on the header MPr 2 and photos taken from the investigated places

The degradation degree of 15Mo3 steel microstructure in the MPr 2 header was tested according to the ASTM E 407-07 [6] and BAS ISO 3057:1998 standards [7]. The position of the replicas is marked on the scheme of the MPr 2 header in Figure 4 where the tested parts of the header are shown and photographed. The assessment of the degradation degree of the microstructure was carried out according to the regulations of VGB-S-517, by comparing it with standards valid for similar steel 14MoV6. Figures 5a, b, c, d, e, and f show the microstructures of the tested replicas with magnifications of x150 and x750. The replicas marked R1 and R2 have an initial degradation degree of microstructure, with

partially coagulated carbides in the boundaries of the pearlite grains (Figures 5a, b, and 5e, f), and were graded according to the VGB-S-517 scale with grade 2a. The structure of replica R3 was rated 3a, and in the microstructure, increased degradation of pearlite lamellae and coarsening of carbides were noted in comparison to replicas R1 and R2 (Figures 5d, and c).

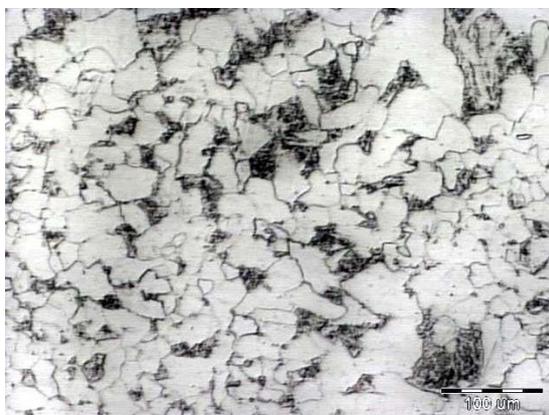
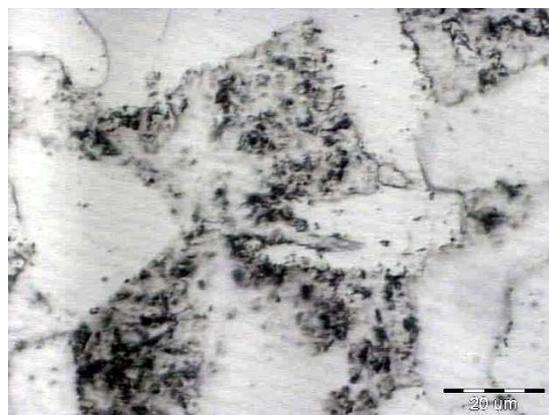
a) Microstructure of the replica R1 (2b)x150

b) Microstructure of the replica R1 (2b)x750

Figure 5. Ferritic and degraded pearlite microstructure with spheroidized coarse carbides inside pearlite grains, with advanced weathering and individual micropores without orientation (a, b, c, d), and more advanced weathering with numerous micropores with orientation (e, f)

Replica (VGB)	Hardness at the point of taking replicas [HB]					
	Individual					Average
R1 (2b)	128	134	136	133	132	133
R2 (2b)	130	128	131	131	128	130
R3 (3a)	126	127	127	126	125	126

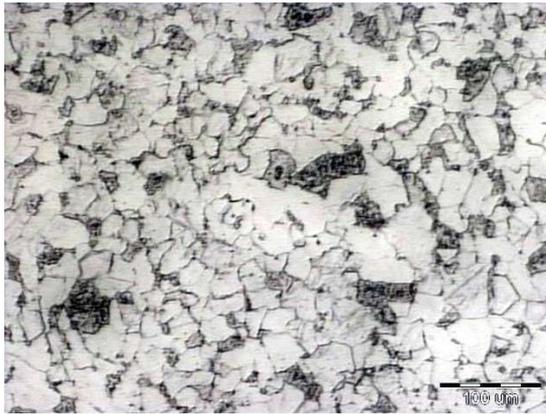
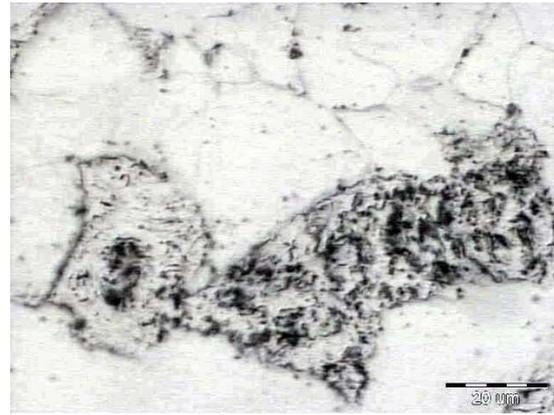
c) Microstructure of the replica R2  
(2b)x150

d) Microstructure of the replica R2  
(2b)x750

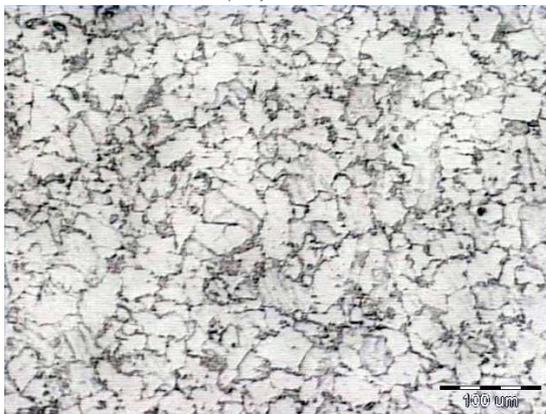
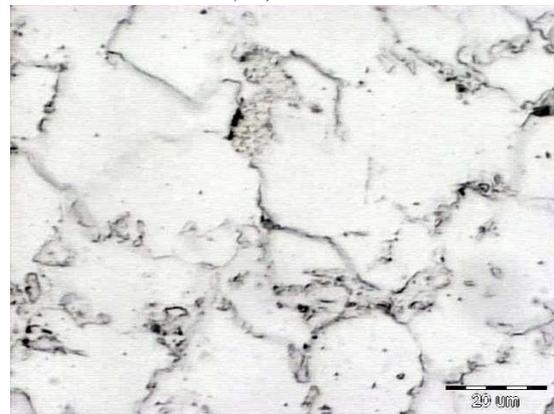
e) Microstructure of the replica R2  
(3a)x150

f) Microstructure of the replica R2  
(3a)x750

Based on the results from Table 2 and from the diagram of the hardness range in Figure 6, it can be seen that all the mean values of the measured hardnesses are below the lower prescribed limit of 133 HB. A particularly low hardness was measured in replica R3, where the degree of degradation is 3a.

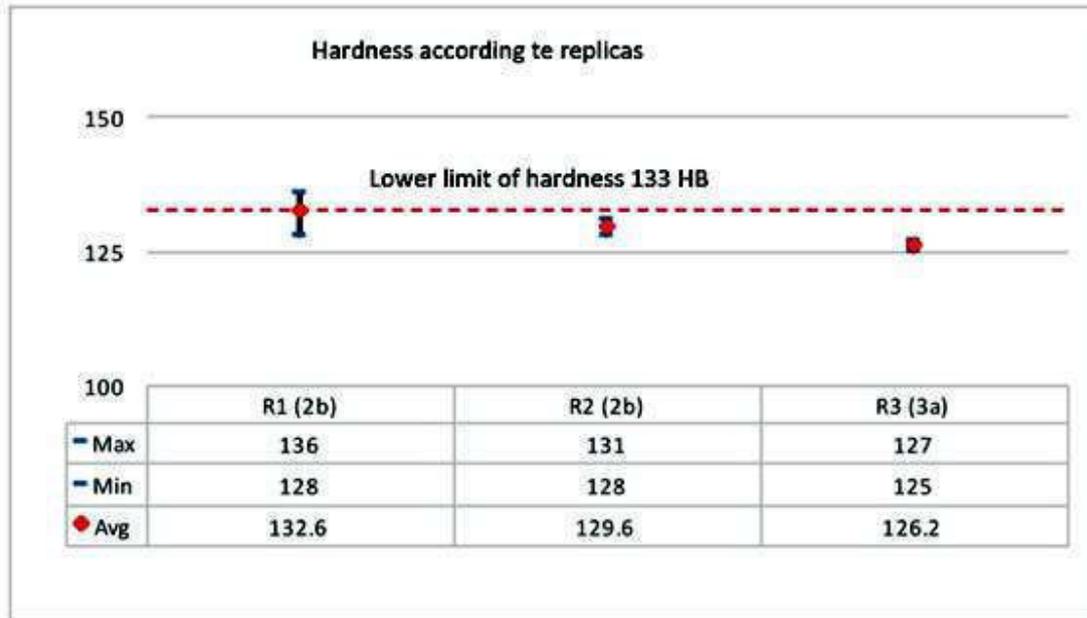
Figure 6. Scattering of MPr 2 header hardness results measured at replicate locations

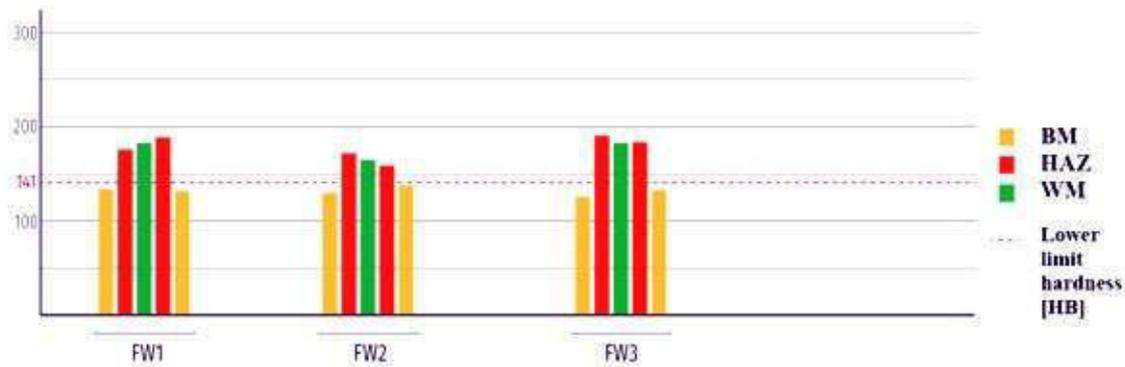
The hardness test on the welded joints of the MPr 2 header was carried out at the places marked on the diagram of the MPr 2 header in Figure 4. The hardness was measured on both sides of the welded joint, on the base material (BM), the heat-affected zone (HAZ), and the weld metal (WM). The results of the test, for the mean values of the measured hardness in all zones of the welded joint, are given in Table 3, and the range of the measured values is shown in the histograms in Figure 7. From Table 3, and from Figure 7, it can be seen that all welded joints FW1, FW2, and FW3 have in the zones of the base material low hardness, which are at the lower prescribed limit, or below that limit, and corresponding to the hardness measured at the points of taking the replicas.

Place	Hardness [HB]				
	BM	HAZ	WM	ZUT	OM
FW1	134	176	183	189	132
FW2	130	172	165	159	138
FW3	126	191	183	184	133

Figure 6. Scattering of hardness on the welded joints of the inlet header of the reheater MPr2
