MICROSTRUCTURAL DEGRADATION OF BOILER HEADERS STEELS UNDER LONG TERM EXPOSURE TO HIGH TEMPERATURE

This paper describes the process of degradation of the structure of the inlet header of the intermediate reheater (MPr) 2 input header at the boiler of Unit 7 of the Thermal Power Plant Kakanj, determined on the basis of tests of replicas and hardness at characteristic places of the header. Headers, with minor delays, have been in continuous operation since 1988. Hardness was tested at replica pickup sites, on the basis of which the correlation between structure degradation and hardness drop resulting from exploitation during the long-term high-temperature operation was estimated.

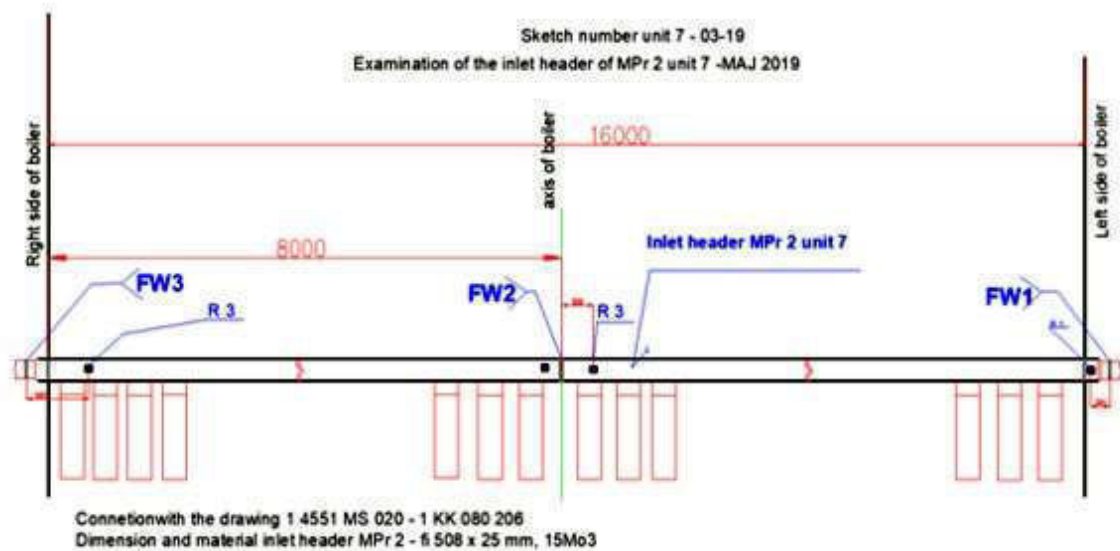
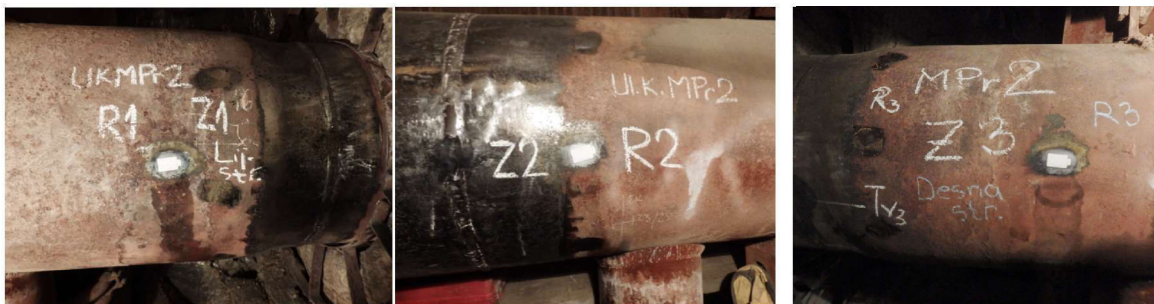
Figure 4. The position of the replicas on the header MPr 2 and photos taken from the investigated places

The degradation degree of 15Mo3 steel microstructure in the MPr 2 header was tested according to the ASTM E 407-07 [6] and BAS ISO 3057:1998 standards [7]. The position of the replicas is marked on the scheme of the MPr 2 header in Figure 4 where the tested parts of the header are shown and photographed. The assessment of the degradation degree of the microstructure was carried out according to the regulations of VGB-S-517, by comparing it with standards valid for similar steel 14MoV6. Figures 5a, b, c, d, e, and f show the microstructures of the tested replicas with magnifications of x150 and x750. The replicas marked R1 and R2 have an initial degradation degree of microstructure, with

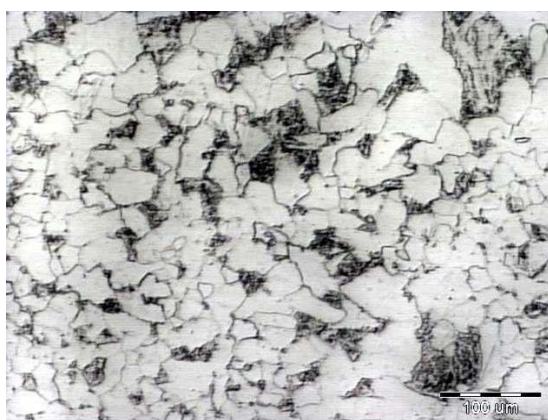
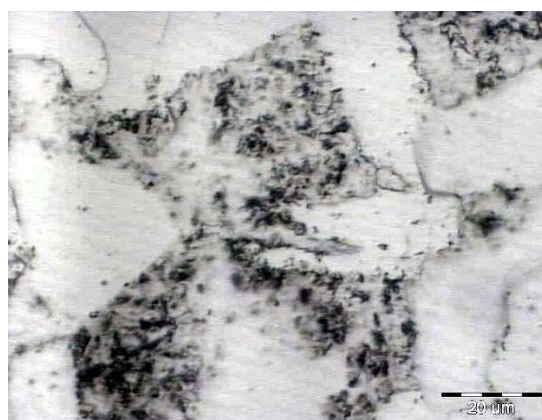
partially coagulated carbides in the boundaries of the pearlite grains (Figures 5a, b, and 5e, f), and were graded according to the VGB-S-517 scale with grade 2a. The structure of replica R3 was rated 3a, and in the microstructure, increased degradation of pearlite lamellae and coarsening of carbides were noted in comparison to replicas R1 and R2 (Figures 5d, and c).

a) Microstructure of the replica R1 (2b)x150

b) Microstructure of the replica R1 (2b)x750

Figure 5. Ferritic and degraded pearlite microstructure with spheroidized coarse carbides inside pearlite grains, with advanced weathering and individual micropores without orientation (a, b, c, d), and more advanced weathering with numerous micropores with orientation (e, f)

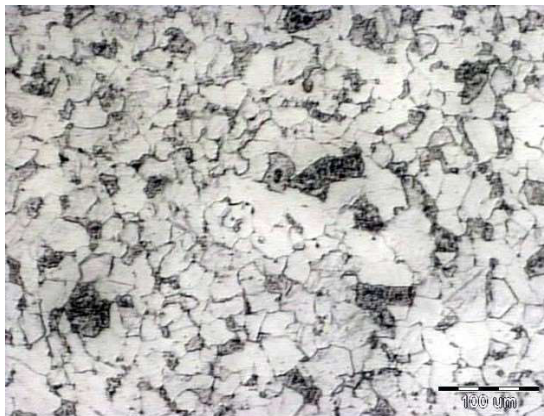
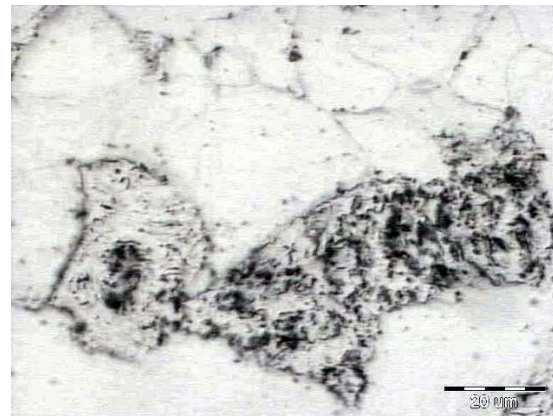
c) Microstructure of the replica R2
(2b)x150

d) Microstructure of the replica R2
(2b)x750

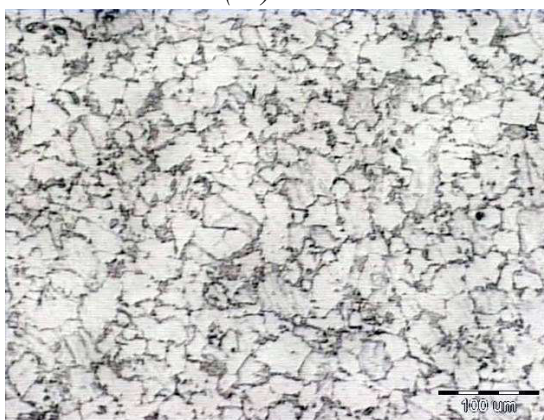
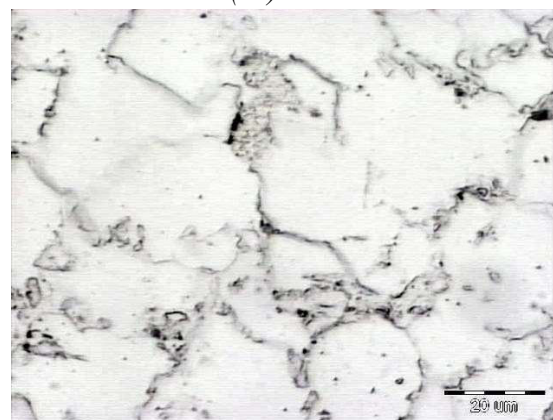
e) Microstructure of the replica R2
(3a)x150

f) Microstructure of the replica R2
(3a)x750

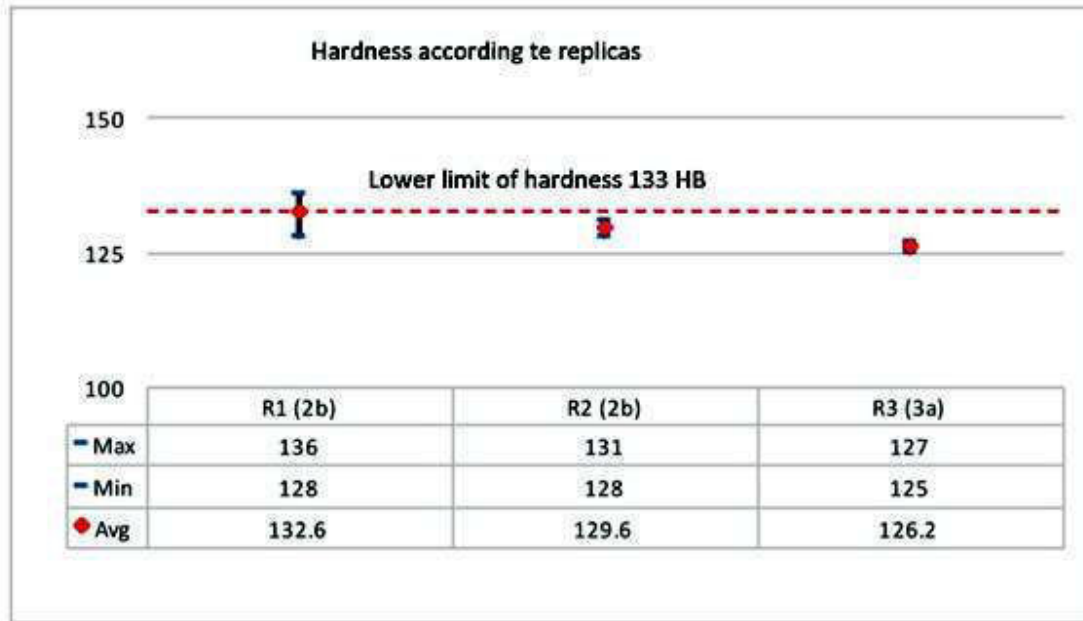
Figure 6. Scattering of MPr 2 header hardness results measured at replicate locations

Based on the results from Table 2 and from the diagram of the hardness range in Figure 6, it can be seen that all the mean values of the measured hardnesses are below the lower prescribed limit of 133 HB. A particularly low hardness was measured in replica R3, where the degree of degradation is 3a.

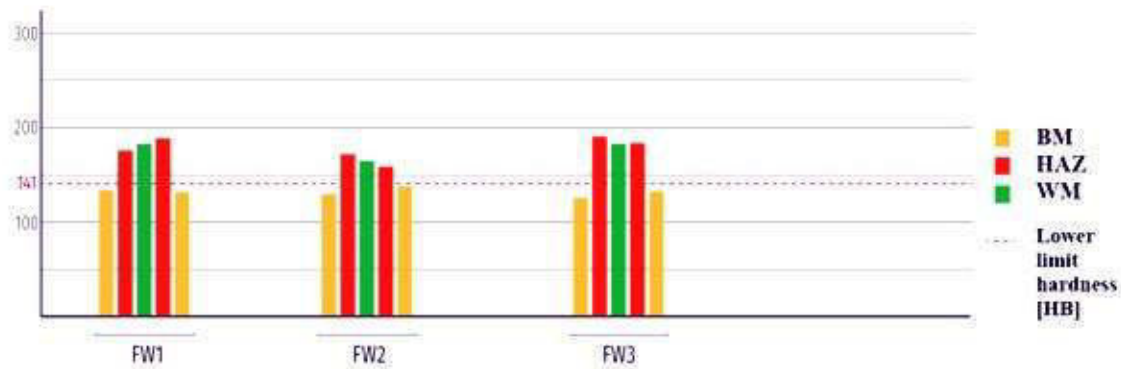
Figure 6. Scattering of hardness on the welded joints of the inlet header of the reheater MPr2

The hardness test on the welded joints of the MPr 2 header was carried out at the places marked on the diagram of the MPr 2 header in Figure 4. The hardness was measured on both sides of the welded joint, on the base material (BM), the heat-affected zone (HAZ), and the weld metal (WM). The results of the test, for the mean values of the measured hardness in all zones of the welded joint, are given in Table 3, and the range of the measured values is shown in the histograms in Figure 7. From Table 3, and from Figure 7, it can be seen that all welded joints FW1, FW2, and FW3 have in the zones of the base material low hardness, which are at the lower prescribed limit, or below that limit, and corresponding to the hardness measured at the points of taking the replicas.
