NDT TESTING AND DETERMINATION OF THE STATE OF THE MATERIALS OF THE HEADERS OF THE BOILER UNIT 5 IN THE THERMAL POWER PLANT KAKANJ

Termoelektrana “Kakanj”
Kakanj, B&H

University of Zenica, Institute “Kemal Kapetanović”
Zenica, B&H

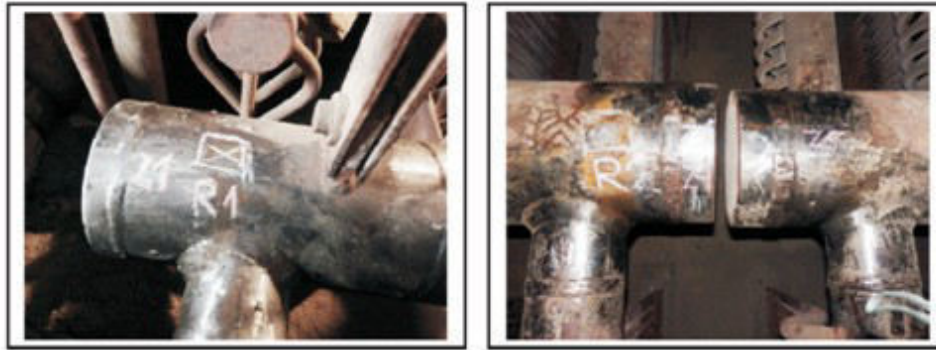
Figure 1. Place of taking the replica at the header of KP 13

Figure 1 shows the place where the replica was taken, and Figure 2 shows the microstructure of replicas R1 and R2 of the chamber of KP 13.

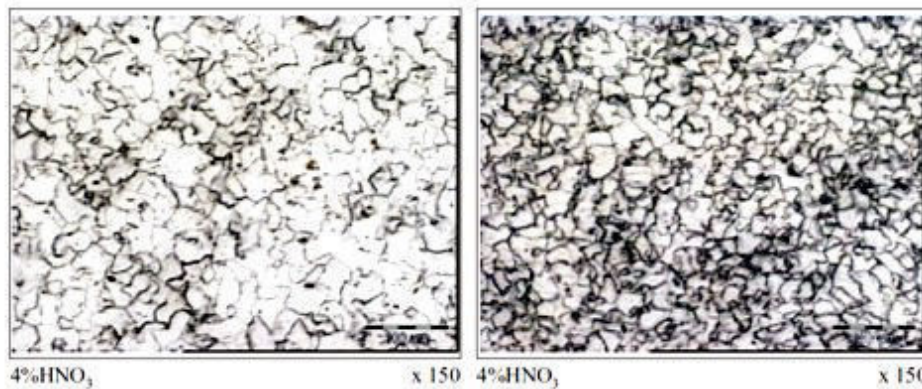
Figure 2. Microstructure of replicas R1 and R2 of header KP 13

All tested microstructures of the replica headers KP 13, KP 14L and KP 14D, and KP 16 of the block 5 boiler superheater were evaluated according to VGB-S-517 regulations with degradation level 3a, which indicates the beginning of complete degradation of the structure due to long-term loading. The tested microstructures on the replicas are completely degraded and consist of ferrites with coarse carbides segregated along the grain boundaries and locally connected in arrays. The presence of bainite and pearlite, which are common microconstituents in the delivery state of this type of steel, was not observed in the microstructures.

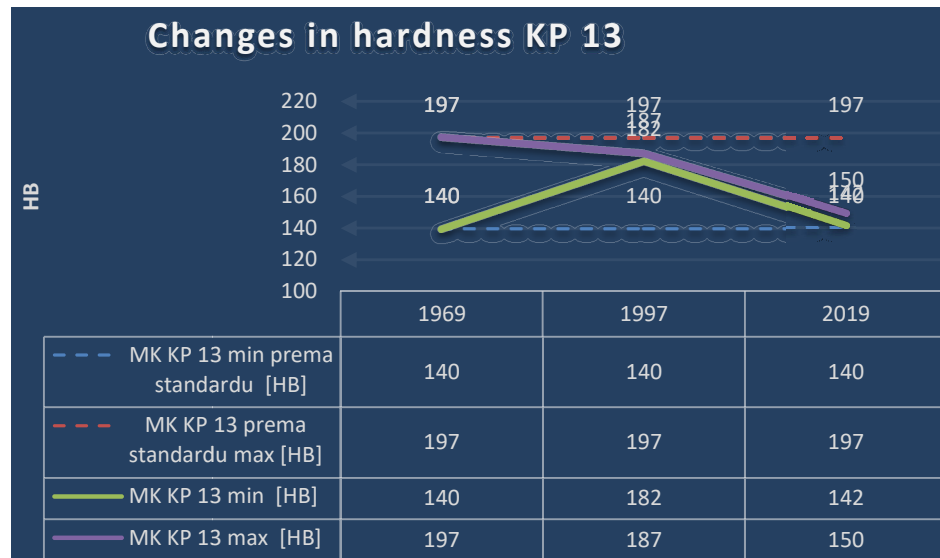
Figure 3. Change in the header of the KP 13 during the period of exploitation

- d) Changes in hardness values are given in Figure 3 for chamber KP 13 with a diagram of hardness changes.

- e) Based on the data from Figure 2 and Table 10, it can be concluded that there has been a significant degradation of the microstructure, since the initial test in 1997, with a grade of 1 for headers KP 14L and KP 14D, and header KP 16, and grade 2a for header KP 13, up to a grade of 3a for all headers examined in 2019.
- f) In the entire exploitation life, the largest drop in hardness since 1997 was recorded in the KP 13 header, in the amount of approx. 55 HB, compared to the KP 14D and KP 14L headers, and the KP 16 header, where this drop amounted to approx. 20 HB.
- g) The summary analysis of test results is briefly described for all tested components in Table 12.

Unit 5 boiler component	Recommendation for exploitation, h	Remark
Header KP 13	15.000	Monitor the development of defects on FW 3
Header KP 14L	10.000	Tighter control
Header KP 14D	15.000	
Header KP 16	10.000	Monitor the development of defects on FW 1.Tighter control.
