NDT TESTING AND DETERMINATION OF THE STATE OF THE MATERIALS OF THE HEADERS OF THE BOILER UNIT 5 IN THE THERMAL POWER PLANT KAKANJ

Armin Husika

Termoelektrana “Kakanj”
Kakanj, B&H

Belma Fakić,

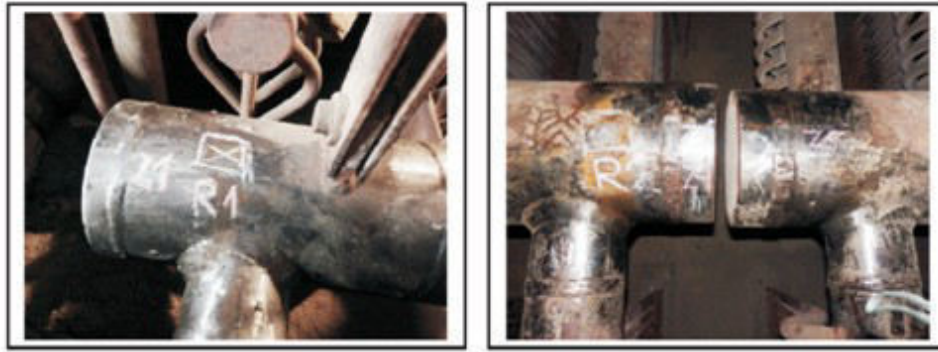
Figure 1. Place of taking the replica at the header of KP 13

Figure 1 shows the place where the replica was taken, and Figure 2 shows the microstructure of replicas R1 and R2 of the chamber of KP 13.

The prescribed values for the hardness of steel 15 128.5 in the normalized state according to the standard ČSN 41 5128 are in the range of 140 to 197 HB. The results of the hardness test at the place of taking the replica headers KP 13, KP 14L and KP 14D, and KP 16 are given in Tables 4, 5, and 6.

Label replicas	Position pipes	Hardness, HB					Middle HB	VGB-S-517
		Individual values						
R1	Left	148	151	149	153	142	149	3a
R2	Middle	151	154	151	148	145	150	3a
R3	Right	142	141	142	146	140	142	3a

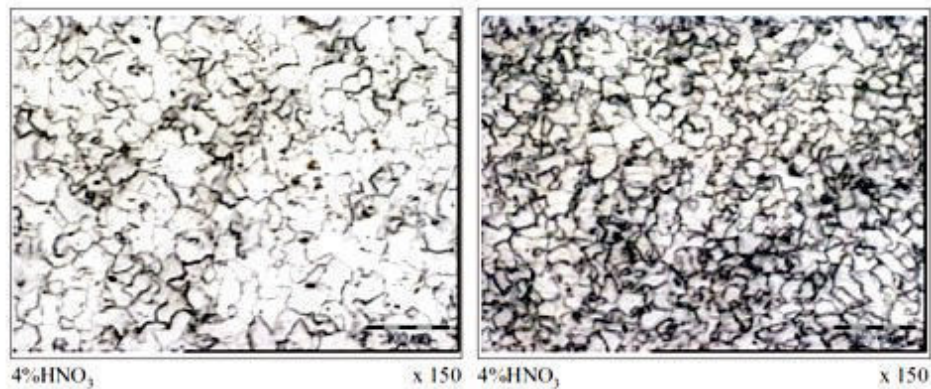
Figure 2. Microstructure of replicas R1 and R2 of header KP 13

All tested microstructures of the replica headers KP 13, KP 14L and KP 14D, and KP 16 of the block 5 boiler superheater were evaluated according to VGB-S-517 regulations with degradation level 3a, which indicates the beginning of complete degradation of the structure due to long-term loading. The tested microstructures on the replicas are completely degraded and consist of ferrites with coarse carbides segregated along the grain boundaries and locally connected in arrays. The presence of bainite and pearlite, which are common microconstituents in the delivery state of this type of steel, was not observed in the microstructures.

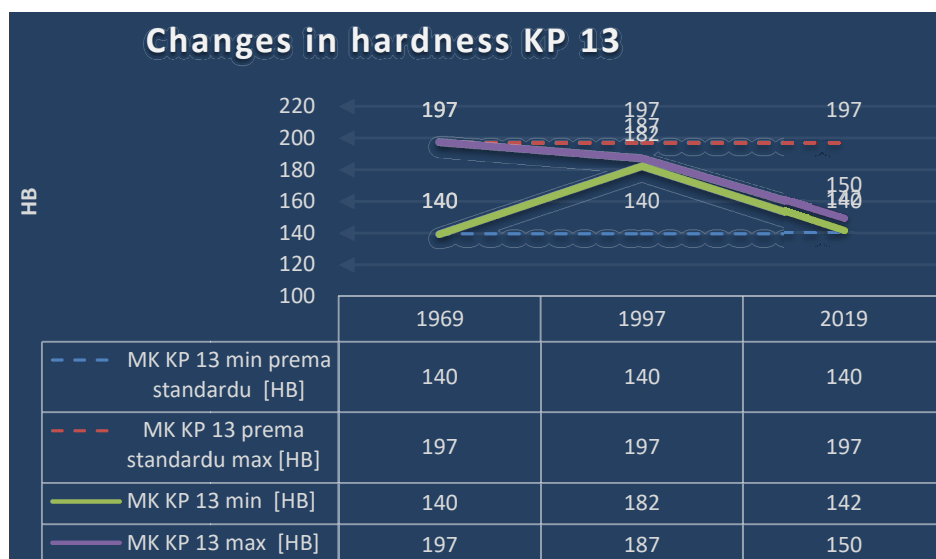
Figure 3. Change in the header of the KP 13 during the period of exploitation

- d) Changes in hardness values are given in Figure 3 for chamber KP 13 with a diagram of hardness changes.

- e) Based on the data from Figure 2 and Table 10, it can be concluded that there has been a significant degradation of the microstructure, since the initial test in 1997, with a grade of 1 for headers KP 14L and KP 14D, and header KP 16, and grade 2a for header KP 13, up to a grade of 3a for all headers examined in 2019.
- f) In the entire exploitation life, the largest drop in hardness since 1997 was recorded in the KP 13 header, in the amount of approx. 55 HB, compared to the KP 14D and KP 14L headers, and the KP 16 header, where this drop amounted to approx. 20 HB.
- g) The summary analysis of test results is briefly described for all tested components in Table 12.

Unit 5 boiler component	Recommendation for exploitation, h	Remark
Header KP 13	15.000	Monitor the development of defects on FW 3
Header KP 14L	10.000	Tighter control
Header KP 14D	15.000	
Header KP 16	10.000	Monitor the development of defects on FW 1.Tighter control.
