## DAMAGES INVOLVING PLASTIC DEFORMATION OF STRUCTURES RELATED TO MAINTENANCE COST REDUCTION

**Dr. Sc. Faik Uzunović**  
Technical Faculty - American Northwest University of Health and Science  
Bosna i Hercegovina

**Key words:** Equipment maintenance, maintenance costs, construction components, failure, breakdown, plastic deformation.

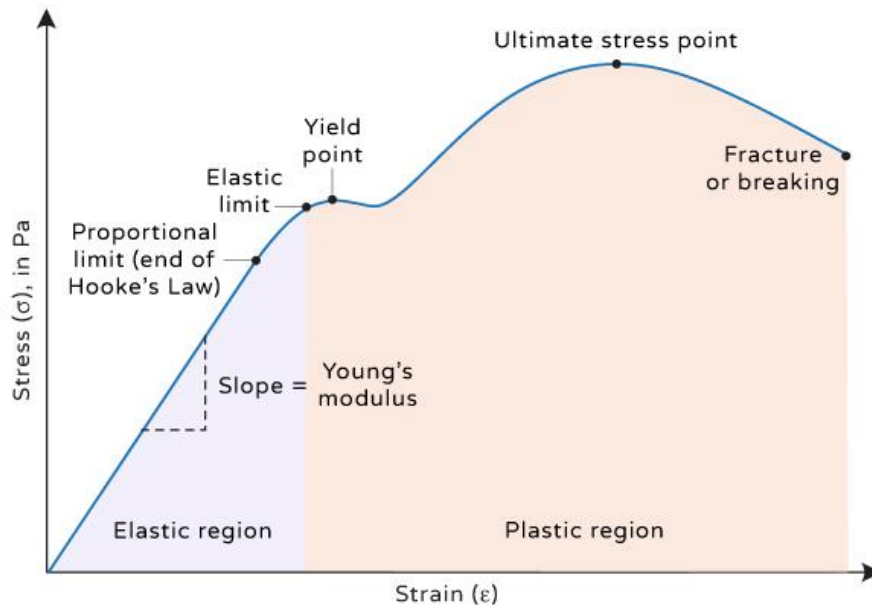
Figure 1 [1] illustrates a typical stress-strain curve obtained from a tensile test of a steel used in construction, conforming to EN 10024 standards for hot-rolled sections such as I-beams, U-channels, and T-bars. The diagram highlights three critical points in the testing process: the yield point, ultimate stress point, and fracture point. These points are essential for understanding the mechanical properties of steel under tensile loading.

Figure 1. Typical tensile test diagram [1]

The Elastic region in Figure 1, which represents the region of elastic deformation, is considered safe under experimental conditions. However, in the long-term application of these steel constructions in B&H industrial companies, this safety can be compromised due to factors such as improper construction, inadequate maintenance, harsh winter conditions, chemically aggressive environments, and vibrations.

The yield point on the stress-strain curve, where plastic deformation initiates, marks the transition from elastic behavior. This point, where the curve flattens, is often challenging to identify precisely. An 'offset yield point,' also known as proof stress, is commonly used in practice. This offset is typically defined arbitrarily at a plastic strain of 0.1% or 0.2%.

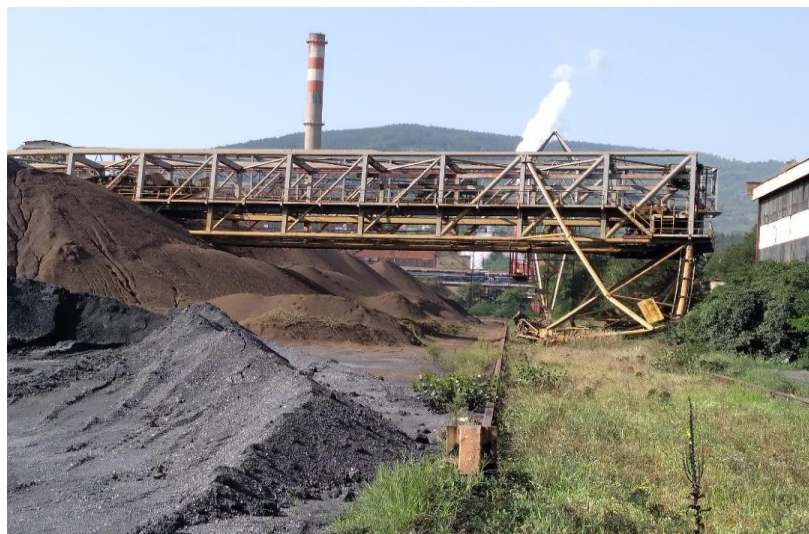
*Figure 2. An example of the broken portal crane*

All these issues (structural failures and damage resulting from significant plastic deformation), as visible in Figures 2 through 12, are primarily caused by inadequate maintenance. These failures often stem from compromises in proper maintenance practices, particularly preventive maintenance (PM), in an effort to reduce maintenance expenditures. This conclusion is supported by an analysis of the maintenance accounting records from the companies involved [2,7,8,9,10]. Furthermore, an overview of the annual maintenance expenses in KM versus production quantity in tonnes (t) is presented in Table 1 and Figure 13.

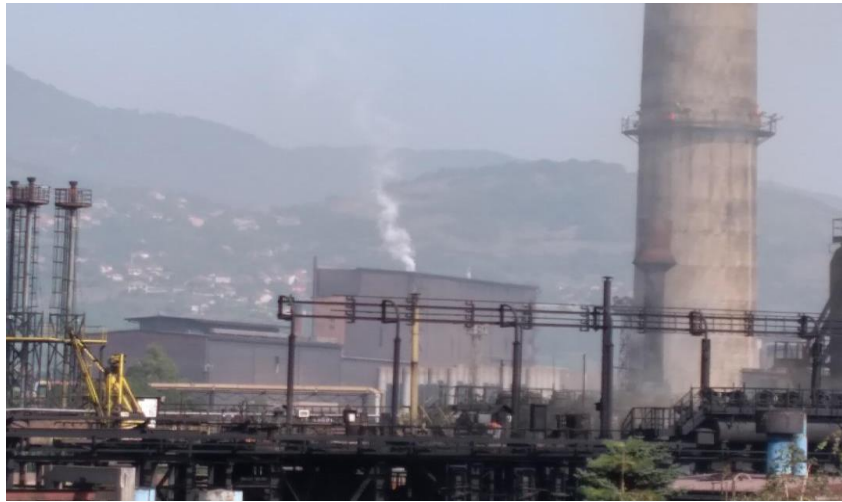
*Figure 3. Western layout view from a broken portal crane*

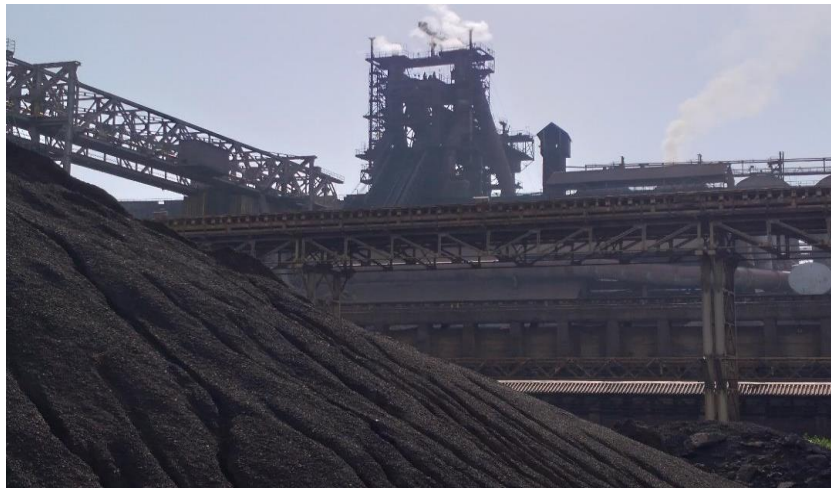
*Figure 4. Eastern layout view from a broken portal crane*

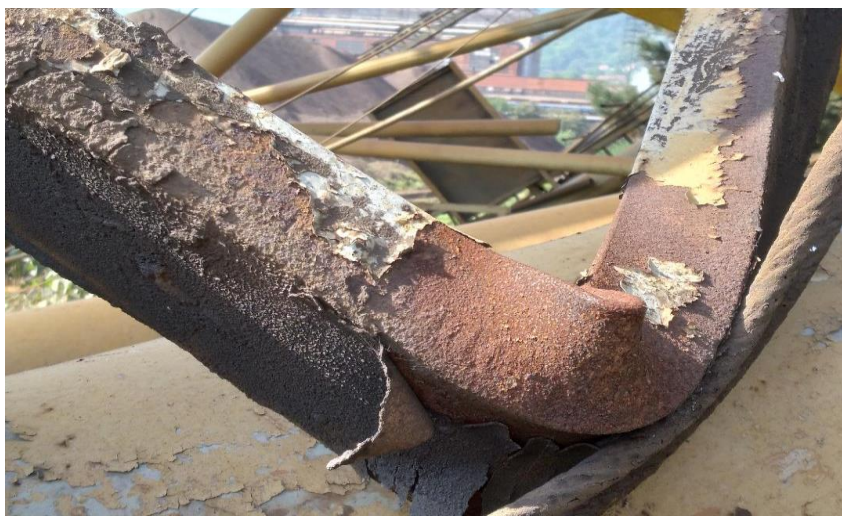
*Figure 5. Detailed view of a severely plastically deformed (bent) section of a broken portal crane*

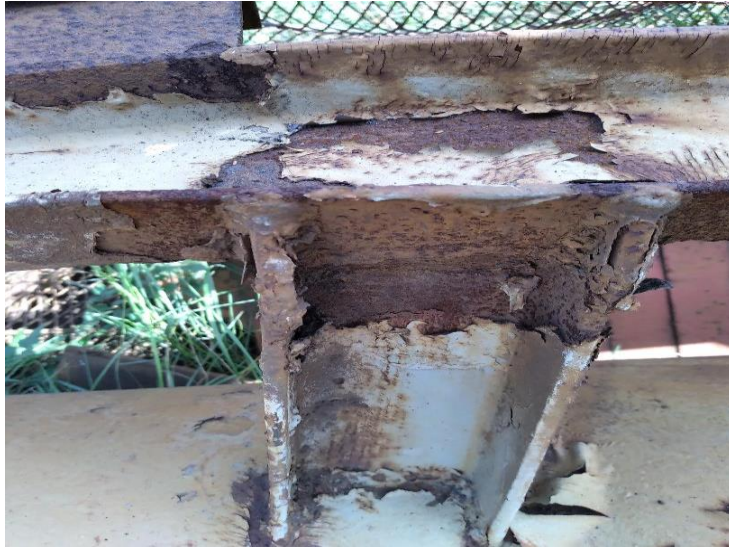
*Figure 6. Detailed position of a deeply corroded section of a broken portal crane*

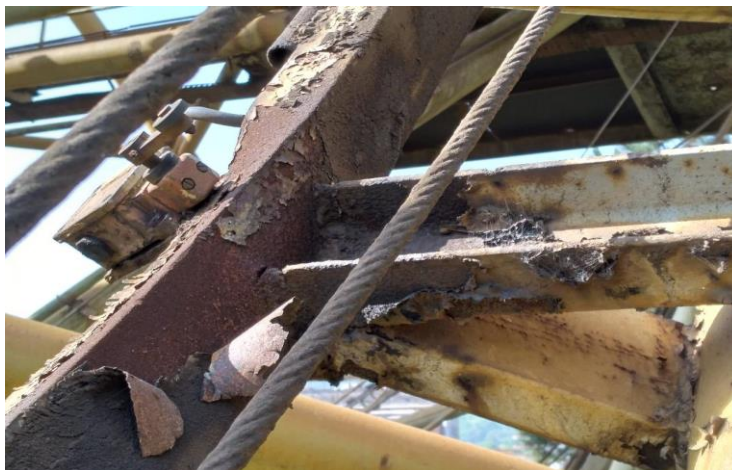
*Figure 7. Detailed position of a welded and deeply corroded section of a broken portal crane*

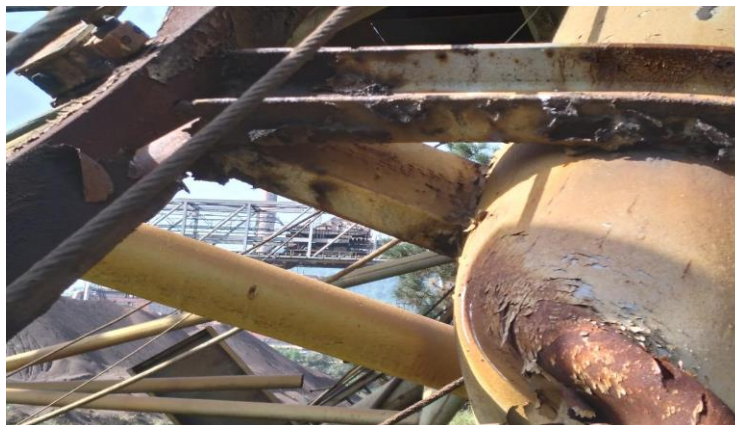
*Figure 8. Detailed position of ductile fracture of a broken portal crane section*

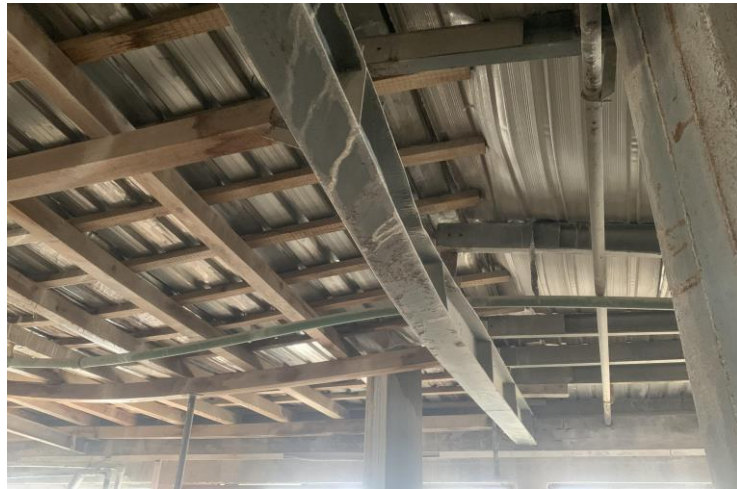
*Figure 9. Position of the wooden and steel construction supports to plastically deformed sections*

Figure 13 clearly illustrates a decline in maintenance expenses. This decrease becomes even more pronounced when depreciation is considered, though that is beyond the scope of this article. The occurrence of plastic deformation in the construction elements, as ominously shown in Figures 9 through 12, serves as a clear indication of inadequate preventive maintenance (PM). This insufficient PM ultimately led to structural issues in the production facility. Furthermore, standard operating procedures (SOPs) had not yet been implemented at the production facility.

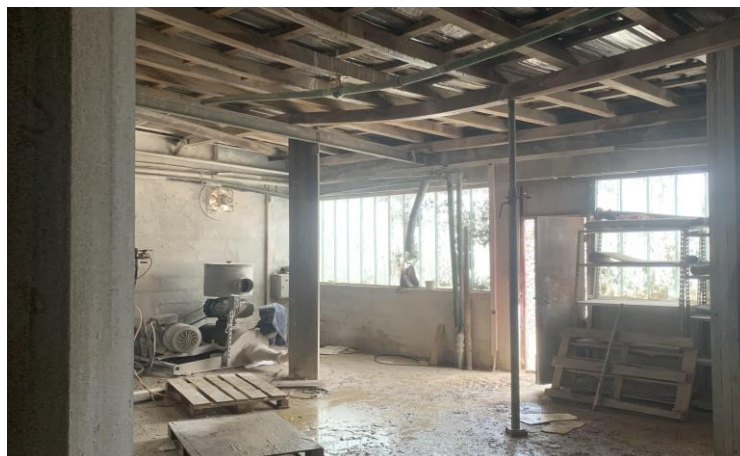
*Figure 10. Another location of the wooden and steel construction supports to plastically deformed sections*

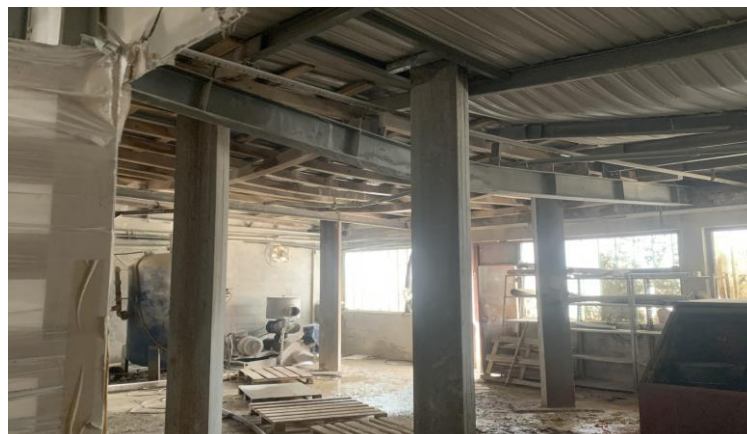
*Figure 11. Position of the wooden construction supports to plastically deformed sections & roof*

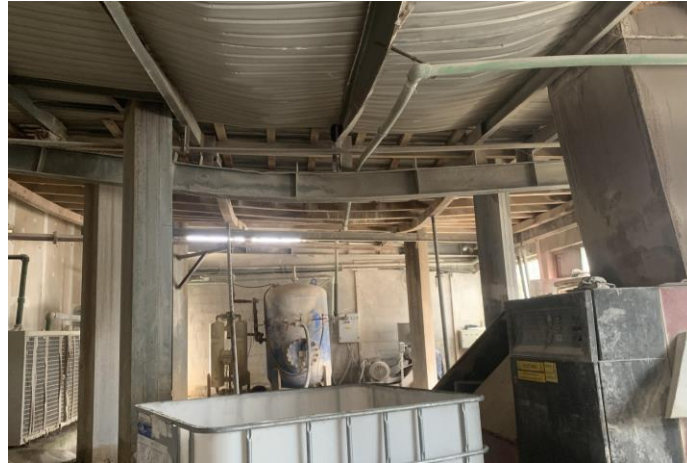
*Figure 12. Detailed position of plastically deformed sections & roof*

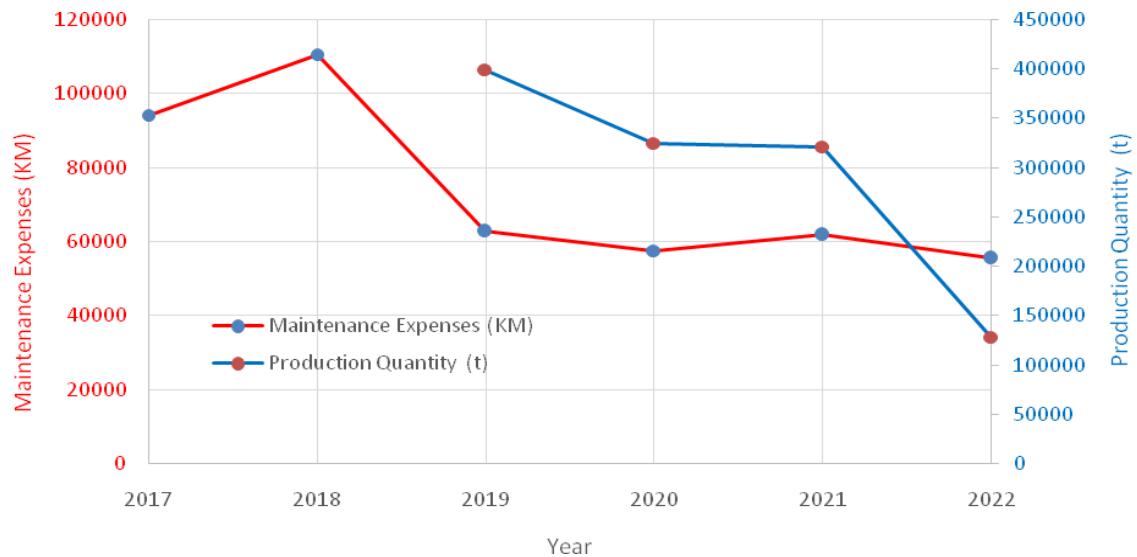
The data from Table 1 are visually represented in Figure 13, where the consequences of reduced maintenance costs become very apparent.

Figure 13. Annual Maintenance Expenses (red line) vs. Production Quantity (blue line)
