PROTAC 500 – ARMORED STEEL OF NEW GENERATION

Jure Bernetič, Gorazd Kosec, Slavko Ažman, Matjaž Marčetič, Boštjan Podlipec
ACRONI d.o.o.
Jesenice
Slovenia

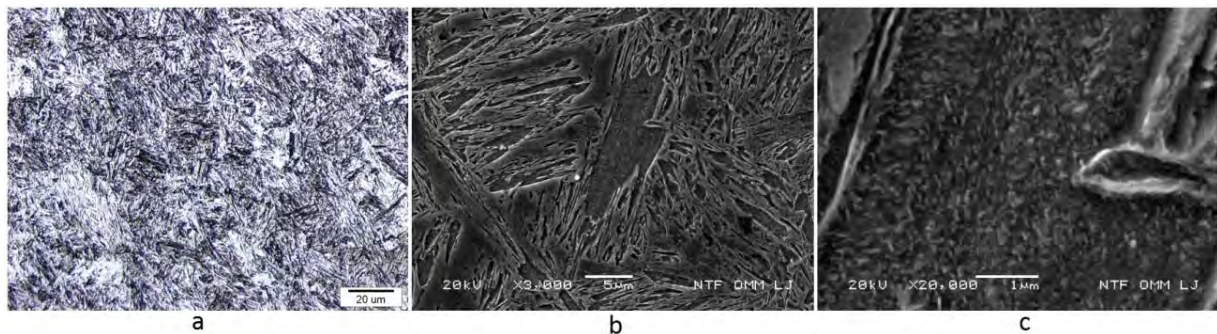
Figure 1. The microstructure of steel PROTAC 500 (a - tempered martensite (OM), b and c - tempered martensite (SEM)).

In Figure 1 there is the microstructure of the steel PROTAC 500 before the ballistic test. The microstructure consists of tempered martensite. In Figure 1c there are the lighter particles of cementite, which is eliminated during the tempering. The hardness of such steel is 540 HV.

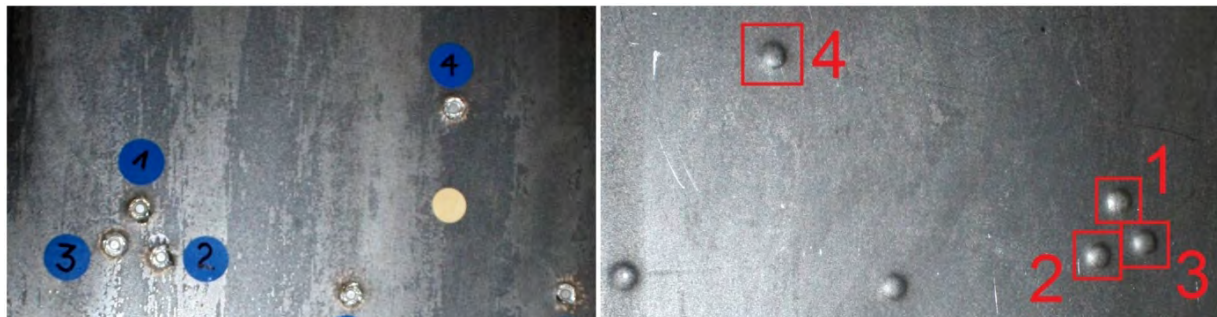
Figure 2. Front (left) and back (right) side of the steel plate after ballistic test.

On the left side of Figure 2 there is a front side of the panels PROTAC 500 after ballistics testing with the markings of four samples were have cut and prepared for further analysis. All armored-piercing bullets are stopped in the plate. In interpreting the results of ballistic tests is the most important information if a bullet penetrates the target. On the right side of Figure 2 there is the back side of the panel after ballistic test. In none of the 6 shots no perforation of the panel occurred.

The parameters of the test results and descriptions of the standard VPAM are in Table 4. By the shot to the sample 1 the bulge with a crack (BmRoL) was formed, that does not transmit light by other shots, but it was smaller bulge without cracks (Ibori). Code SS in the description of the result means that the ball remains in the target, and consequently, cast the whole kinetic energy of the target.

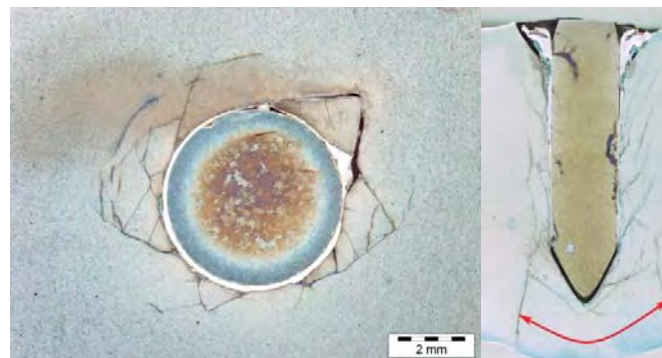
Figure 3. Macroscopic cross-sectional images of the sample 1.

For a more detailed picture of the interactions between bullets and plate the samples for metallographic analysis were prepared. Figure 3 consists of a macro picture of sample 1 cross-sections. In Figure 3 there is a cross-sectional view of the upper level of the sample, where there are a significant number of cracks, and branched adiabatic shear bands (ASB) which extend from the border between the envelope bullets (bright narrow band around the circumference of the core) and the base material towards the interior of the target. In Figure 4 is represents the scanning electron microstrucrograph of fractured surface of armored steel plate.
