## APPLICATION OF THE BAS EN ISO 1463:2022 STANDARD IN THE CHARACTERIZATION OF PIPE MATERIALS FOR THERMAL ENERGY PLANTS

**Belma Fakić, Adisa Burić, Edib Horoz**

University of Zenica, Institute “Kemal Kapetanović”  
Zenica, B&H

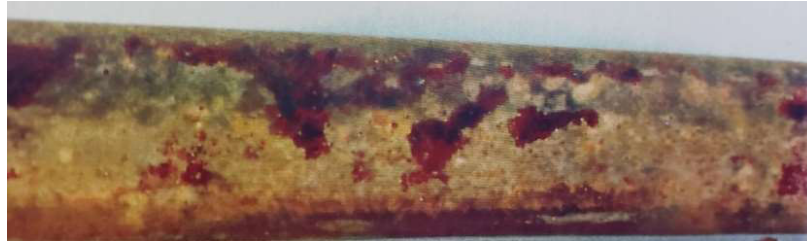
*Figure 1. Pipe of steam reheater, after exploitation [8]*

For the purposes of this work, the sample of steam reheater pipe  $\phi$  45x6 mm, made of material 13CrMo4-4 was prepared. After years of exposure to the high temperature and pressure that exist in thermal power plants, a significant presence of oxide layers on the inner and outer walls of the pipes was observed. The chemical composition of pipes according to the standard DIN 17175 [5] and chemical analysis are given in Table 1.

The thickness of the oxide layer is measured using the software Analysis 5.1 with a light microscope OLYMPUS PMG3. The input to the software is calibrated using a calibrated object micrometer. The choice of magnification at which the measured oxide layer is observed is between one and a half and three times the thickness of the oxide layer. The appearance of the pipe from which the sample was taken is given in Figure 1. Representative micrographs of the oxide layer are given in Figure 2.

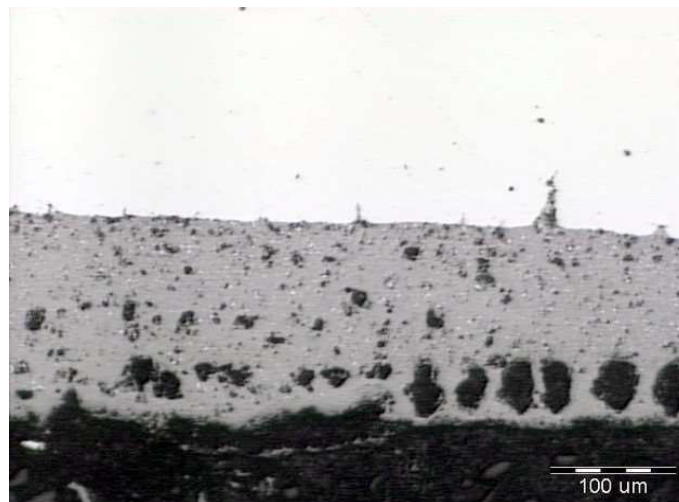
x150

Uneatched

*Figure 2. The oxide layer, inside the wall of the pipe [8]*

The result of measuring the thickness of the oxide layer was:  $165,2 \pm 3,2$  microns.

The measured value of the thickness of the oxide layer on the inner wall of the pipe  $\phi 45 \times 6$  mm, made of material 13CrMo4-4 in the value of  $165,2 \pm 3,2 \mu$  indicates that attention should be paid to the remaining life of the pipe. Namely, the application of an oxide layer on the inner wall of the pipe for operational conditions in thermal power plants (temperatures over  $450^\circ\text{C}$ ) can lead to degradation of the microstructure [1], because the oxide layer will act as a thermal insulator, causing local overheating of the pipe.
