## CONTRIBUTION TO INVESTIGATION OF THE INFLUENCE OF WELDING ON THE HARDNESS AND MICROSTRUCTURE OF SUPERALLOY NIMONIC 80A

prof.dr.sc. Raza Sunulahpašić, prof.dr.sc. Almaida Gigović-Gekić  
Faculty of Engineering and Natural Sciences, University of Zenica  
Travnička cesta 1, Zenica  
B&H

### ABSTRACT

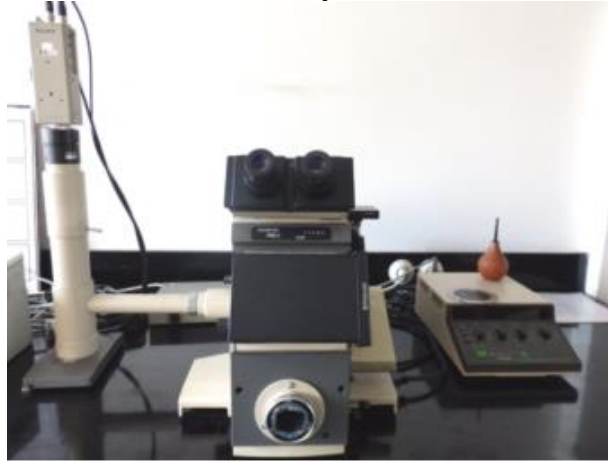
The microstructure testing was conducted using an OLYMPUS PMG3 light microscope, Figure 5. This testing included the analysis of the microstructure of the base material (BM), heat-affected zone (HAZ), and weld metal (WM). Microstructure testing of the HAZ under the light microscope was limited due to the narrow width of this part of the welded joint. Therefore, the microstructure in the HAZ was examined at the section of the welded joint where changes in the microstructure were clearly visible.

*Figure 5. OLYMPUS PMG3 Microscope*
